PRECISION DYNAMICS LAKE DAM

LOUDOUN COUNTY, VIRGINIA

PHASE I INSPECTION REPORT

NATIONAL DAM SAFETY PROGRAM

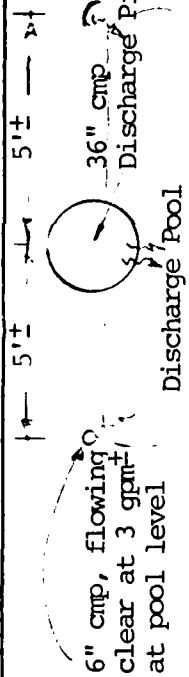
<p>Similar flows observed on 6-15-81 4-5" opening water stone bed. Flowing clear at 5 gpm\pm. 6" above pool</p>
MATERIALS	<p>Fine to coarse silty clayey sand, with gravel and boulders up to 2½ ft in length (SC) to fine to coarse silty sand with gravel and boulders (SM). Some scattered brown silty clay, trace fine sand (CL) also present.</p>	-
